# Flame Scanner Failure Bulletin

## Safety Note

SF-17-14-US  
November 2017  
© 2017 Honeywell International Inc.

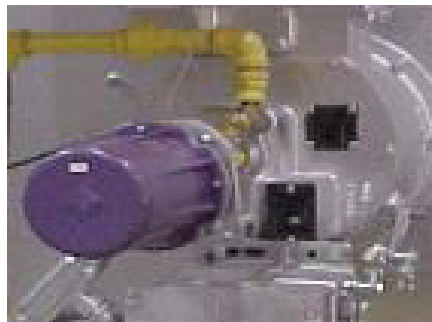
**The testing found four ultraviolet scanners failed in one concentrated area of an oven.**

Upon further investigation, high ambient temperatures were identified as a possible cause. These non-self-checking scanners failed to indicate that a flame was always present. The source of the problem is believed to be a hot air duct near the burners.

Manufacturers usually don't expect them to operate in environments of over 150° F; (specific manufacturers' requirements need to be identified). The life of electronic components and scanners degrades considerably with higher temperatures.

**We are now working with the plant to monitor ambient temperatures throughout this oven's gas trains to better understand where future problem areas may exist.**

We have identified non-reversing temperature strips that can be applied to components for this purpose. These are relatively inexpensive - about \$5 per component. They can be installed in minutes and then checked in a day or two to see the highest temperature achieved at the surface of a component. This technology is the least expensive approach we've found for monitoring ambient conditions for paint ovens, process ovens, and heat-treat gas train components.

Scanners that have just been replaced should be tested 24 hours and then again within three days. If they are still functioning after three-days, they will probably have longevity. We have found that some scanners fail in just a couple days and may be on equipment that runs for weeks or months in between shutdowns.
